**ALABAMA HAZARDOUS WASTES MANAGEMENT AND MINIMIZATION ACT
(AHWMMA)**

Compliance Evaluation Inspection (CEI) Report

Hanil E Hwa Interior Systems Alabama, LLC
200 Craig Industrial Drive
Selma, Dallas County, Alabama 36702

February 25, 2016

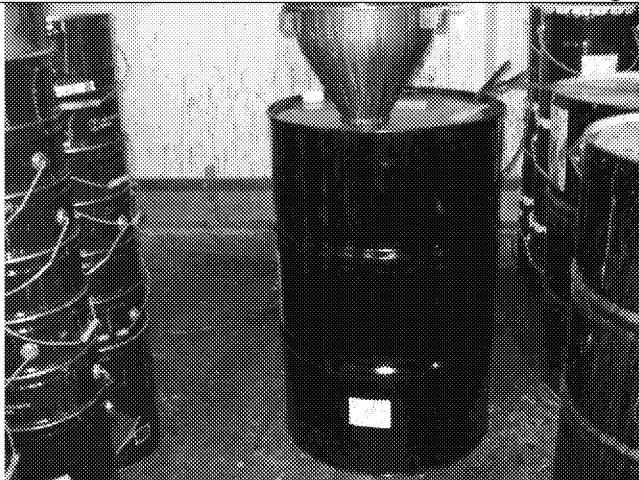
In this area, the upper trim of each door panel is painted to match the specified color code. Solvent and paint wastes are generated when the paint guns are purged between color batches. At the time of the inspection, there was one 55-gallon close-top satellite accumulation container staged in the product area to receive the purged solvent. This drum was equipped with a latching funnel screwed into the bung. The drum was closed, but it was not marked or labeled in any way. See Photograph #2.

2. Paint Shop – unmarked SAA container

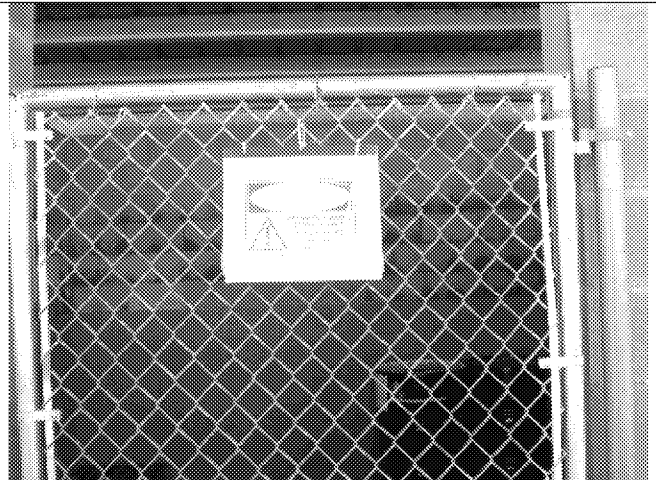
The HWSA is a small concrete block building located at the northwest end of the access road that runs along the rear of the main facility. The entrance to the HWSA is closed by a locked personnel gate. A paper sign with the legend “Danger – Hazardous Waste Storage Area – Unauthorized Persons Keep Out” was affixed to the gate. Inside the HWSA, there were two 55-gallon close-top drums, which Mr. Rossi said held paint waste. The drums were closed and appeared to be in good condition but were not labeled with the words “Hazardous Waste”, the applicable EPA hazardous waste numbers or an accumulation start date. The floor of the HWSA appeared to be uncoated concrete; at least one crack was visible. See Photographs #3 and #4.

3. 90-day accumulation area

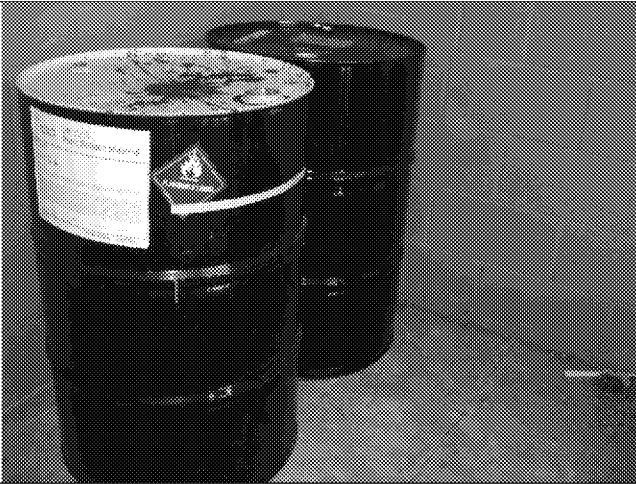
4. HW Storage – unlabeled, undated drums

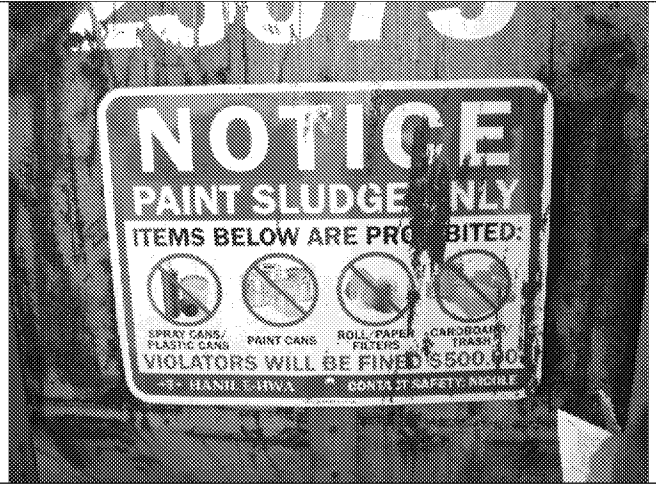
Immediately south of the HWSA, we observed a roll-off container of water-based paint sludge. Per Mr. Rossi, the paint sludge is nonhazardous waste. A sign on the roll-off container warned employees not to place any other material in the container. See Photographs #5 and #6.

5. Sign on paint sludge roll off

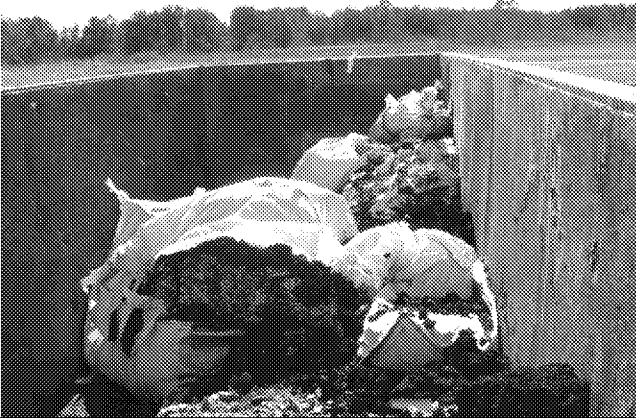
6. Contents of paint sludge roll off

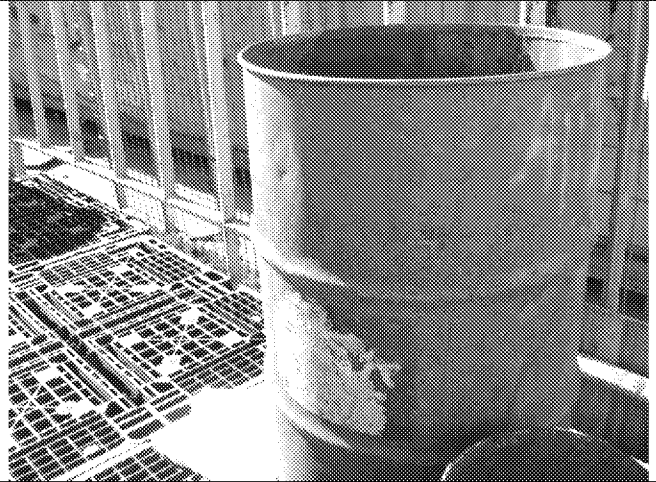
On a spill pallet beside the roll-off container, there was an open-top 55-gallon drum that held 12 discarded, intact aerosol cans of "Per-Fix Flaw Repair Coating 7205AA". Upon testing, some of the cans still held dispensable product. According to the Safety Data Sheet, the product includes three components that are U-listed hazardous wastes when discarded: ethyl acetate (EPA hazardous waste number U112); xylene (U239); and toluene (U220). The drum was open, unmarked, and very rusty. There were dozens of aerosol can caps on the ground beside the spill pallet and in the spill pallet itself. Neither facility representative was able to tell us how Hanil manages the aerosol cans or their contents. See Photographs #7 through #9.

7. Open, unmarked drum containing spent aerosols

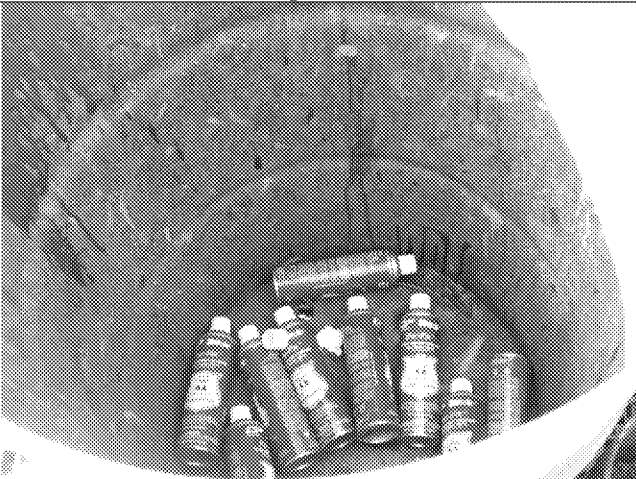
8. Drum containing spent aerosols

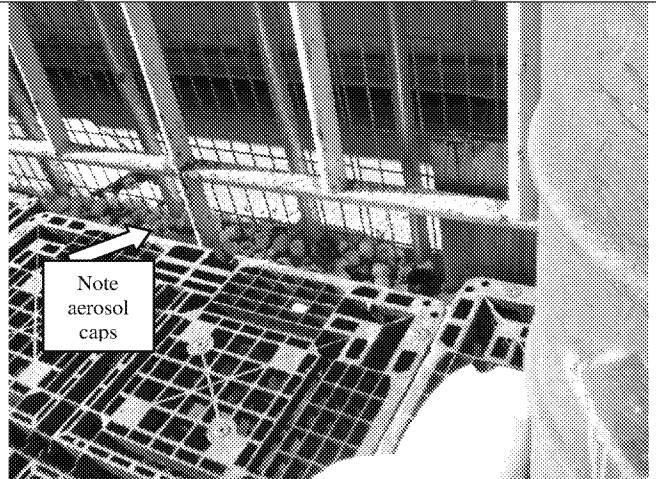
9. Discarded caps from aerosol cans

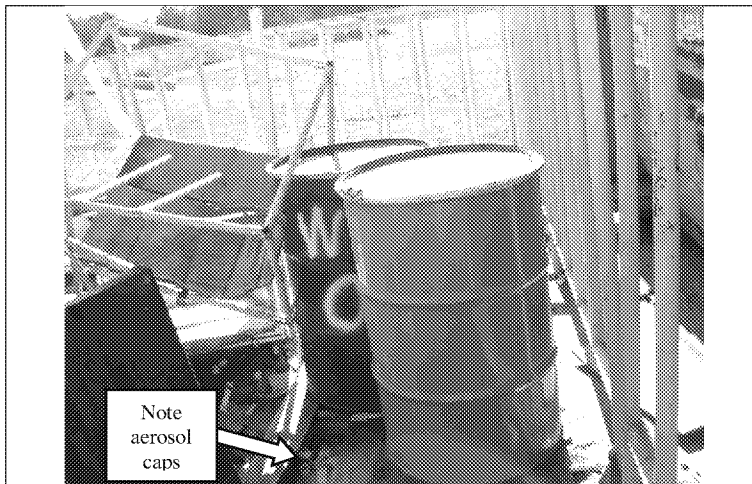
Behind the drum holding the aerosol cans, there were two more open-top 55-gallon drums; these drums were closed. Facility representatives were unsure of their contents. Upon opening, both drums appeared to hold used oil; one drum also held seventeen additional aerosol container caps. One drum was not marked in any way; on the other drum, the spray painted letters "WA" and "O" were visible, but the area was too crowded to ascertain the rest of the markings. The drum lids were secured with clamping rings. See Photographs #10 and #11.

10. Unmarked or improperly marked UO drums

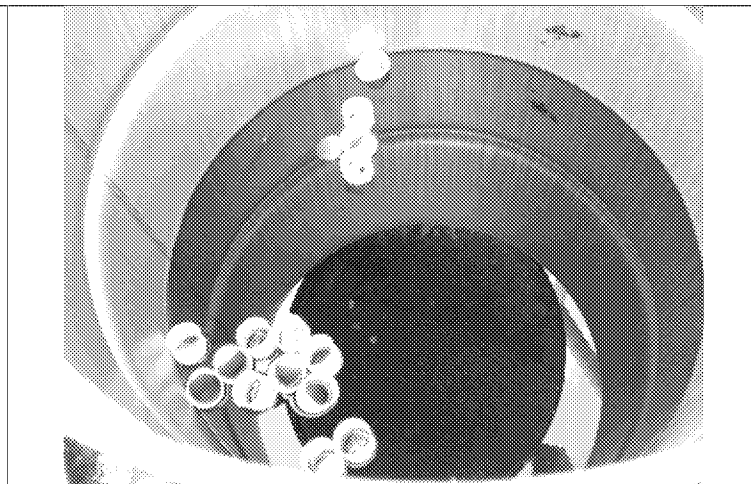
11. Used oil and discarded caps from aerosols

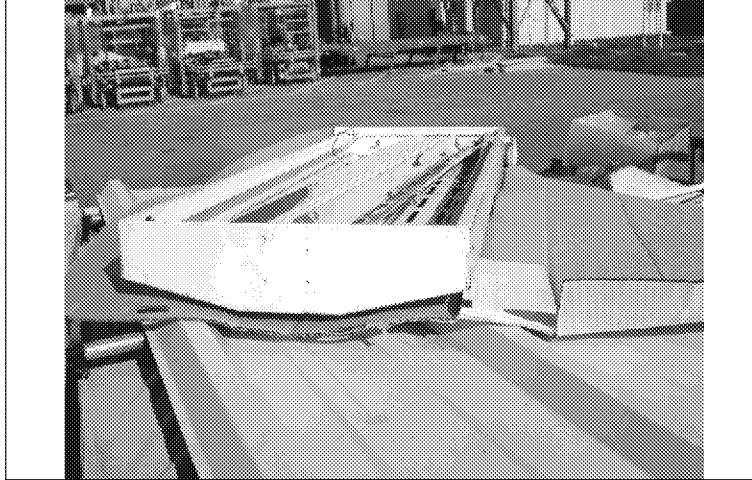
One fluorescent light fixture and five bent high intensity discharge (HID) light fixtures had been discarded in this area. The fixtures were stored with no protection from the weather. The facility representatives were not sure if the fluorescent fixture was useable; however, they stated the HID fixtures could not be used because of their bent metal bodies. See Photograph #12.

12. Discarded fluorescent fixture

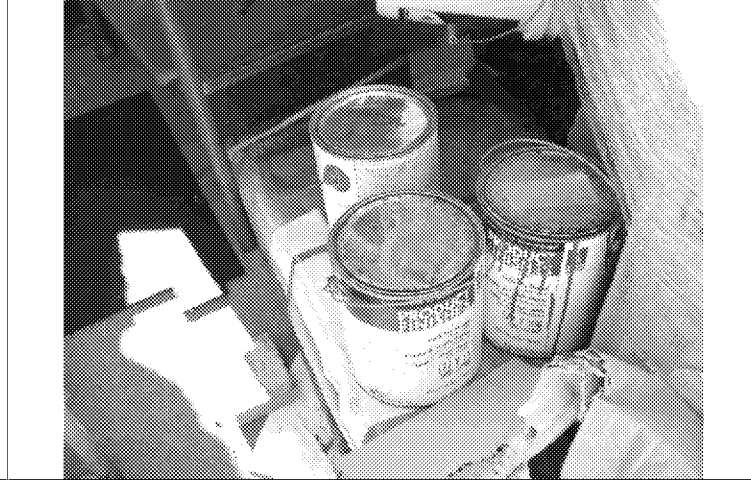
A few feet to the south of the light fixtures, we saw three 1-gallon cans of "Quick Dry Enamel" paint that were stored out of doors with no protection from the weather or temperature extremes; two of the cans had rusted lids. The content of at least one can seemed to have solidified. The facility representatives were not sure if the other two cans were usable product or waste. See Photograph #13.

13. Discarded paint

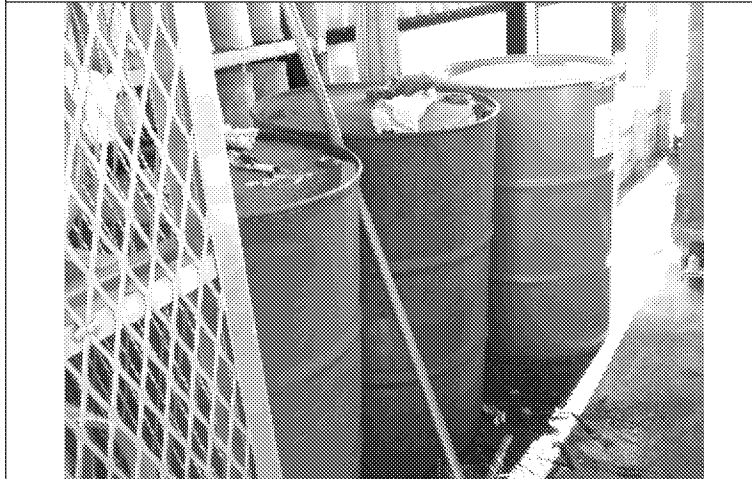
Staged near the aforementioned paint cans, there were five additional 55-gallon drums; three drums were open-top, while two drums were close-top. All drums were closed, but there was some oily staining visible at the base of the two close-top drums. Upon investigation, all were found to contain used oil. None were marked with the words "Used Oil". The drums all appeared to be structurally sound, but the lid of one close-top drum appeared to be somewhat rusted. See Photographs #14 and #15.

14. Three unmarked used oil drums; note staining at base

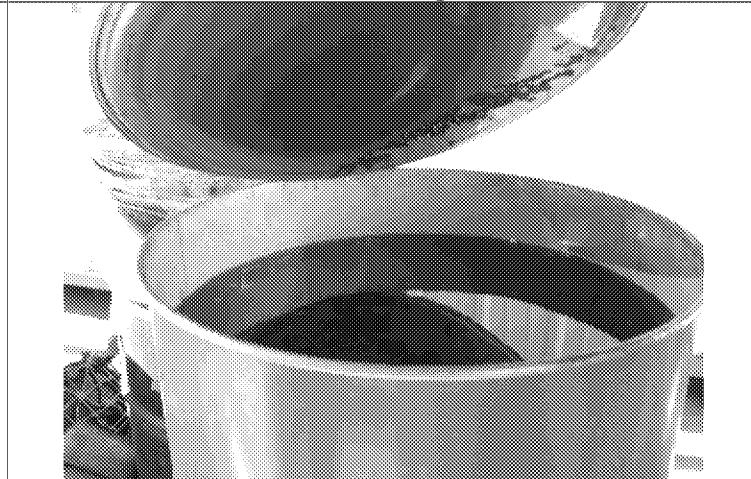
15. Unmarked drum holding used oil

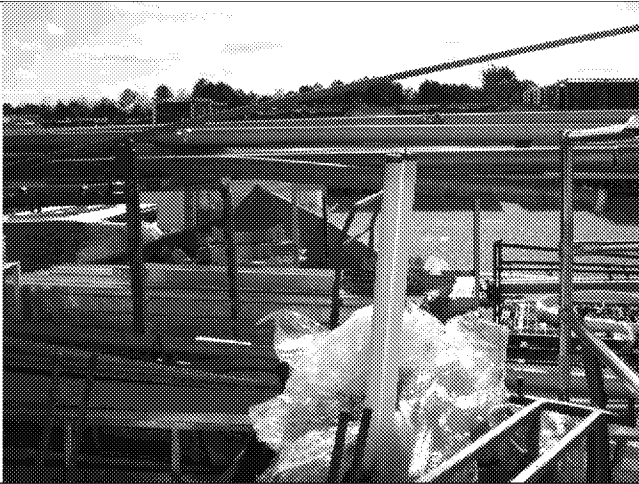
In this same area, we observed two fluorescent lamps that had been placed in a trash can along with discarded plastic film. Again, the facility representatives were not sure if these lamps were usable or discarded. See Photograph #16.

16. Fluorescent lamps

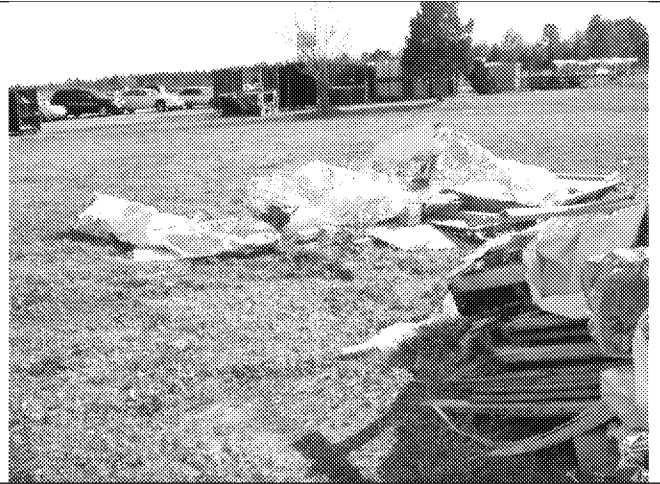
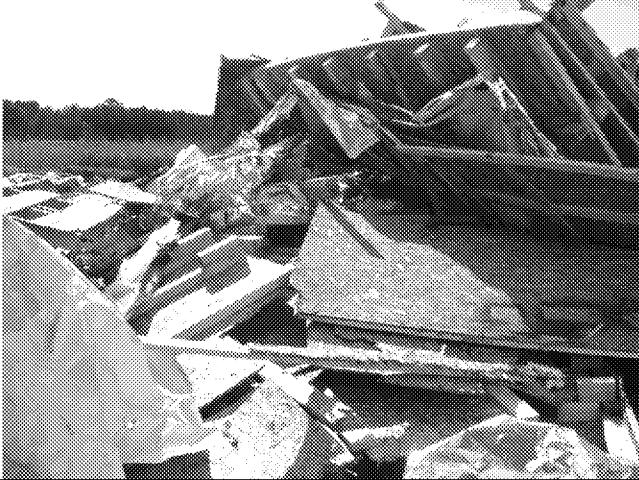
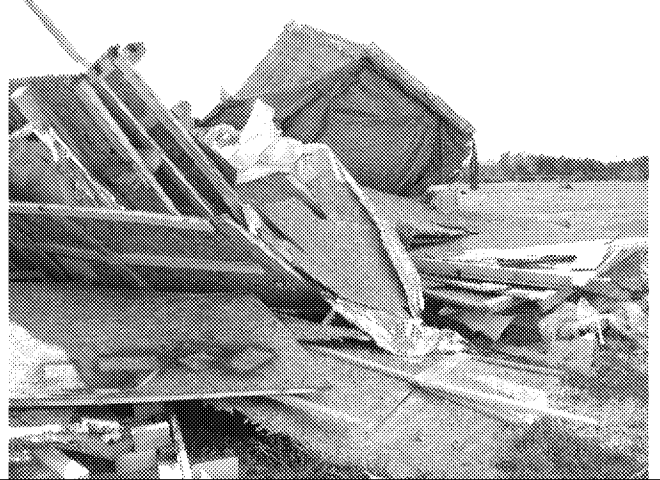
In the field behind the Laydown Area, there was a large pile of discarded construction materials, including weathered and broken sheets of oriented strand board plywood (chip-board), 2x4 lumber, and sheets of foil vapor barrier. In addition, we saw one discarded aerosol can of lacquer paint among the debris. The facility representative were not able to say when the material had been deposited or when it would be removed. See Photographs #17 through #20.

17. Construction material dump

18. Construction material dump

19. Construction dump

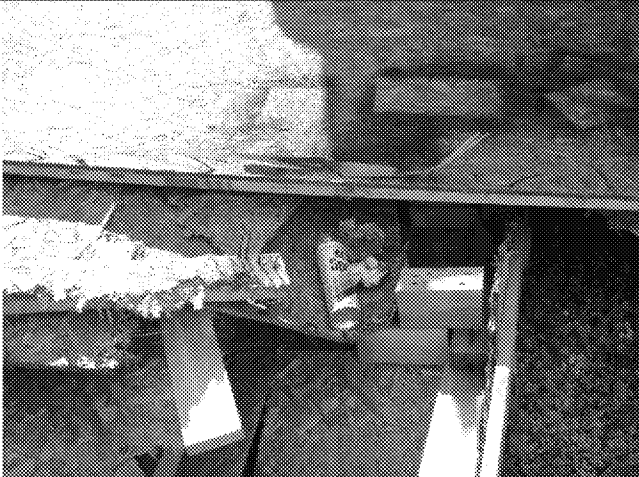
20. Construction dump – note discarded aerosol can

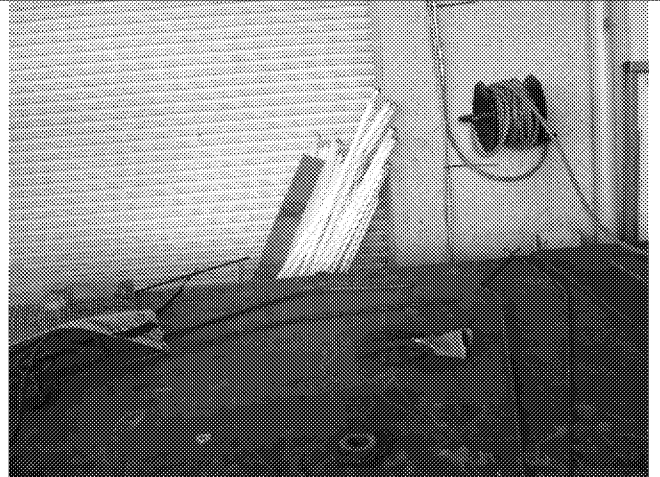
In this area, parts stands and other equipment used throughout the facility are repaired and/or painted. In the area immediately outside the Maintenance Shop, between the welding table and the wall, there were, at least, two dozen fluorescent lamps in a plastic trash container. Mr. Robitaille said they had been kept there since, at least, December [2015] and that he thought some of them were still useable. Inside the Maintenance Shop, we found one damaged HID light fixture with the remnants of a broken lamp and an open 1-gallon can of enamel paint; the can was about half full and the contents had solidified. See Photographs #21 through #23.

21. Fluorescent lamps “stored” outside maintenance shop

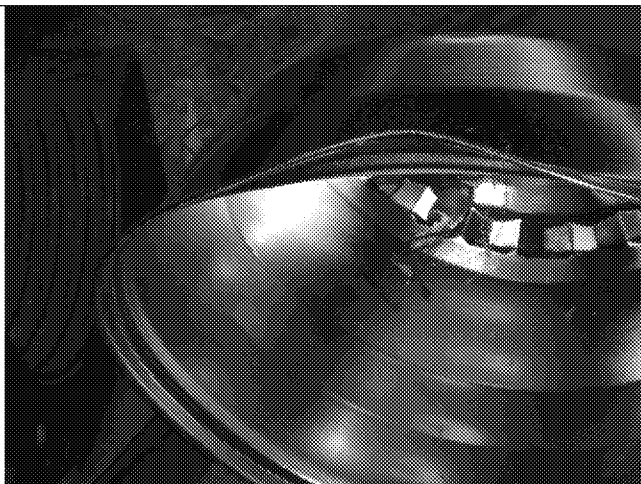
22. HID lamp broken in fixture

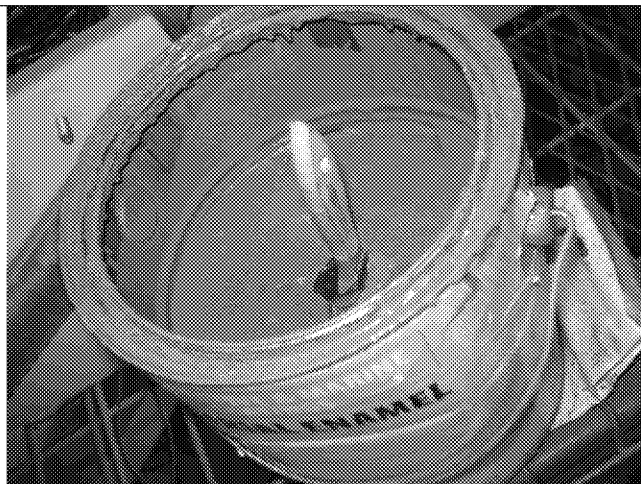
23. Solidified enamel paint

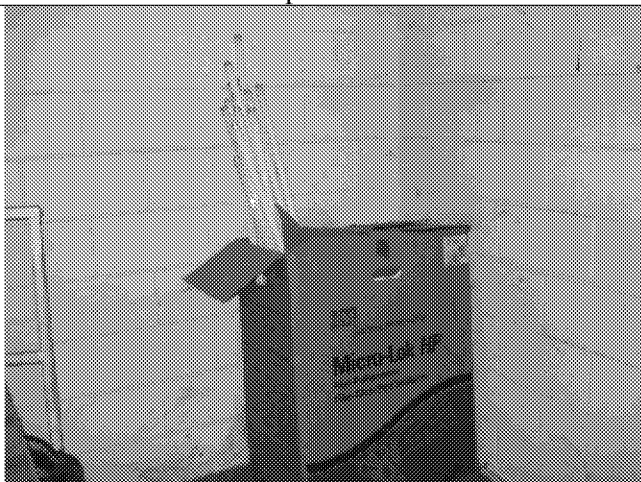
Spent fluorescent lamps and other lighting wastes are stored in the Electrical Room, which is adjacent to the Maintenance Shop. At least, 15 spent fluorescent lamps were protruding from the top of a corrugated cardboard box of filters. The box was not closed, dated or marked with the words "Universal Waste" or "Hazardous Waste". We also saw three HID light fixtures in this area; these appeared to be intact, and two still held intact lamps. Mr. Rossi and Mr. Robitaille were not sure if they were still useable or if they had been discarded. See Photographs #24 and #25.

- In the electrical room, at least fifteen spent fluorescent lamps were protruding from the top of a corrugated cardboard box of filters. The box was not closed, dated, or marked with the words "Universal Waste" or "Hazardous Waste".

24. Spent fluorescent lamps stored in box containing filters

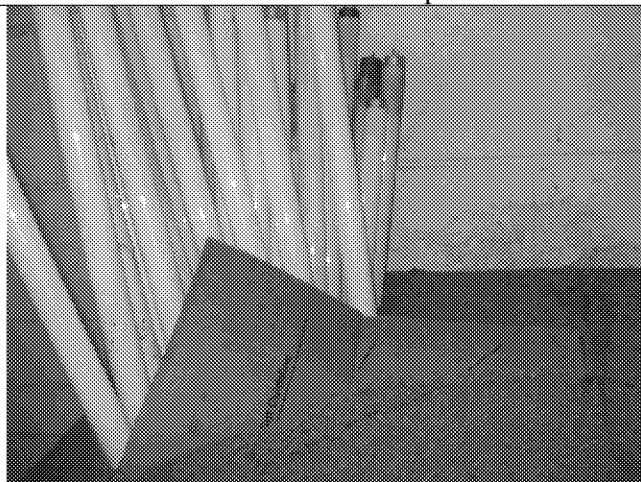
25. Close up of spent lamps
